REVISED ERADICATION PLAN FOR *CAULERPA TAXIFOLIA* IN CALIFORNIA: SURVEILLANCE, ERADICATION, AND CURRENT STATUS.

Merkel & Associates, November 2001

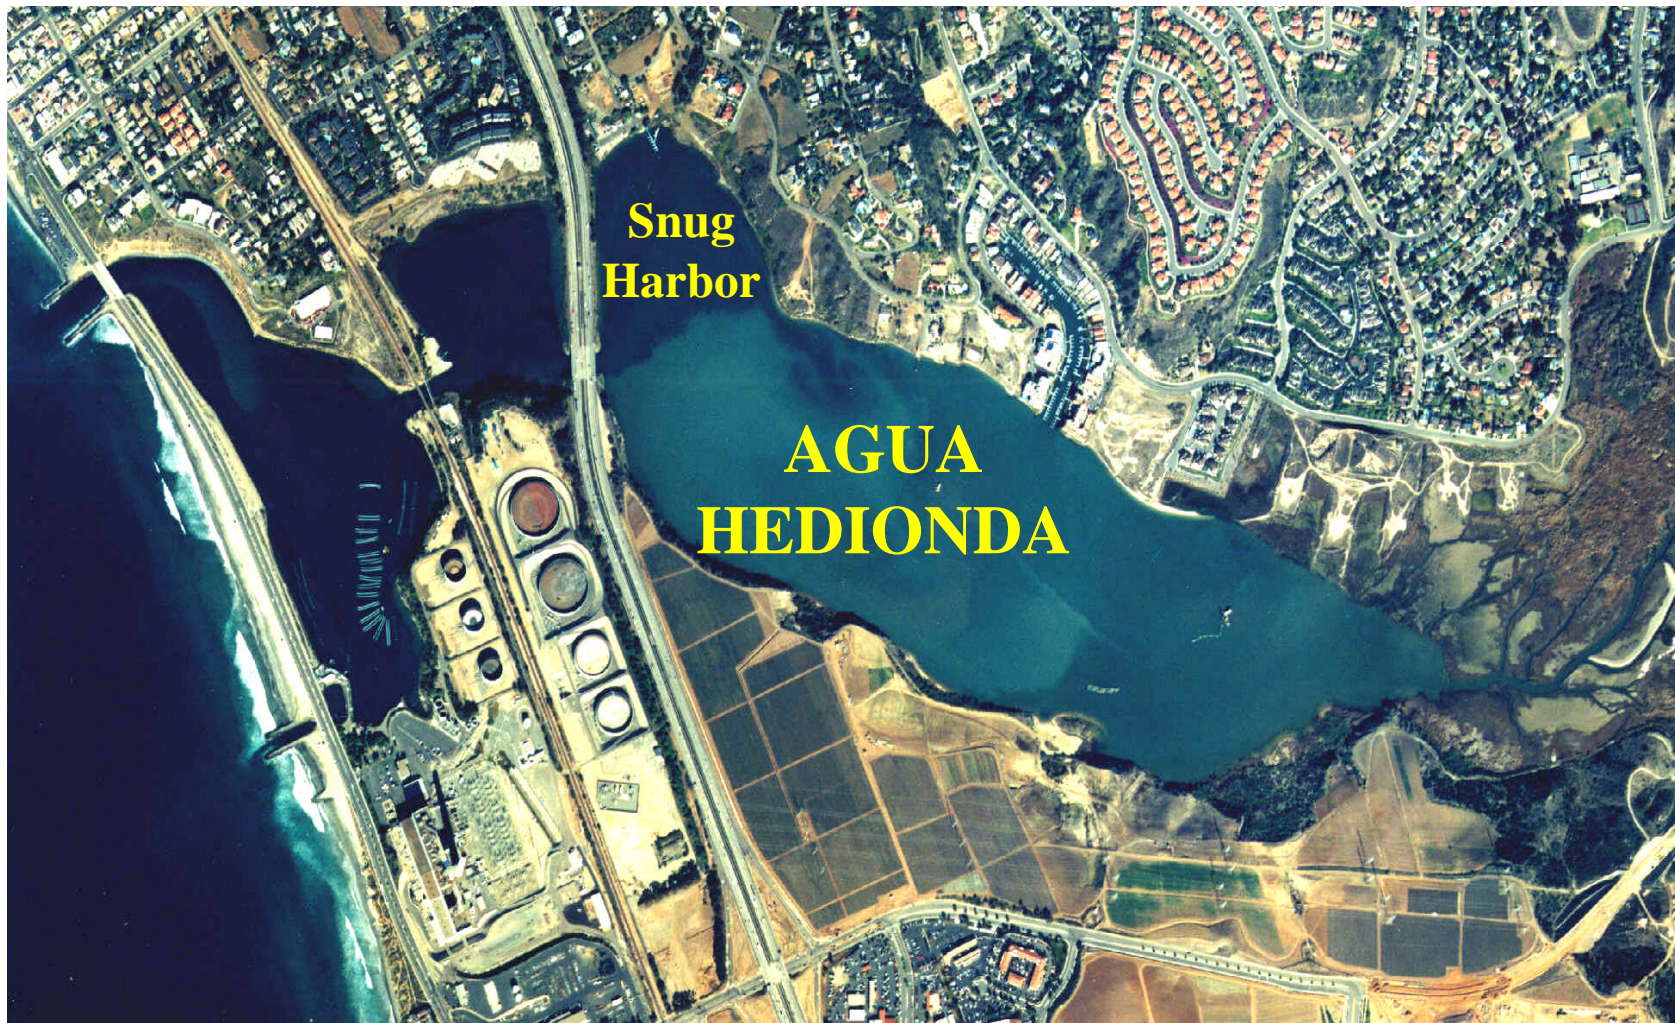
Figure
1

Agua Hedionda
June 2000
Carlsbad, CA

The highly invasive Mediterranean strain of the tropical alga, *Caulerpa taxifolia*, has become established in Agua Hedionda Lagoon, Carlsbad, California, where it was first discovered in June 2000 (Figure 1). This site represents the first known occurrence of this invasive strain within the Western Hemisphere and is considered to pose a major threat to coastal ecosystems, as well as to recreational and commercial uses of resources. While the species has now been confirmed at a second site in Huntington Harbour, Huntington Beach, California, Agua Hedionda reflects the larger of the known infestations (Figure 2). It is not known whether other infestations also exist and the continued wide availability of this species in the commercial aquarium trade is of high concern.

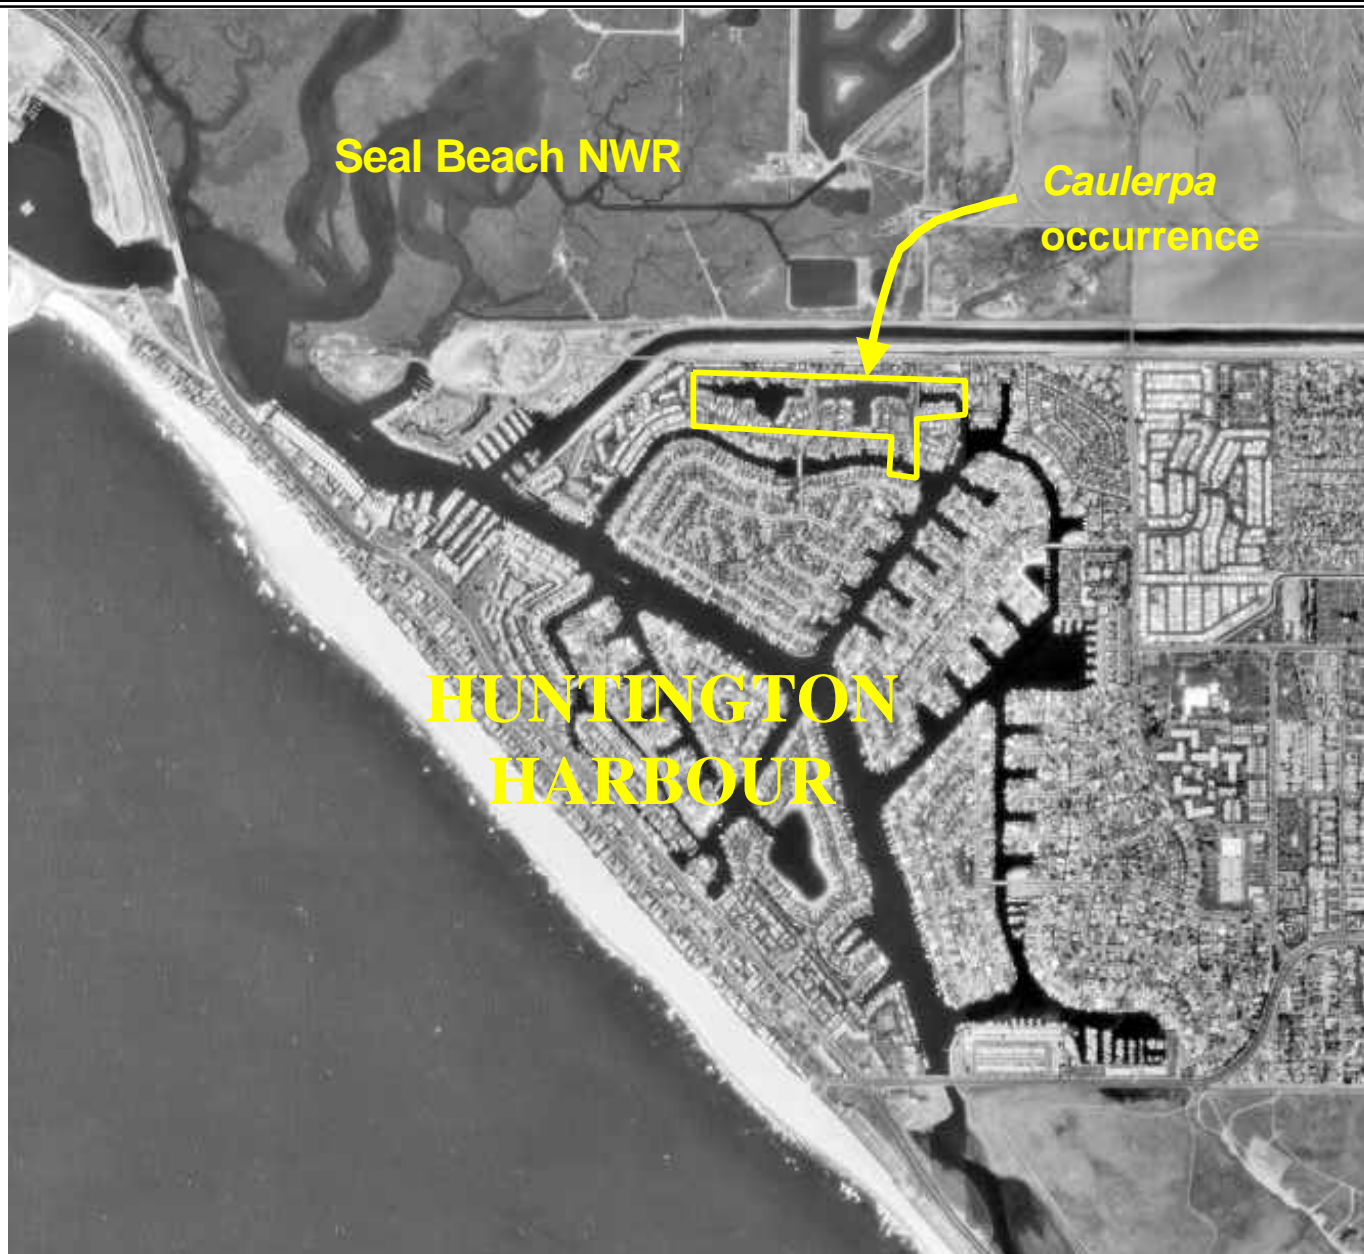
Figure
2

Map of Known *Caulerpa taxifolia* Infestation in Huntington Harbour
October 26, 2000
Huntington Beach, CA

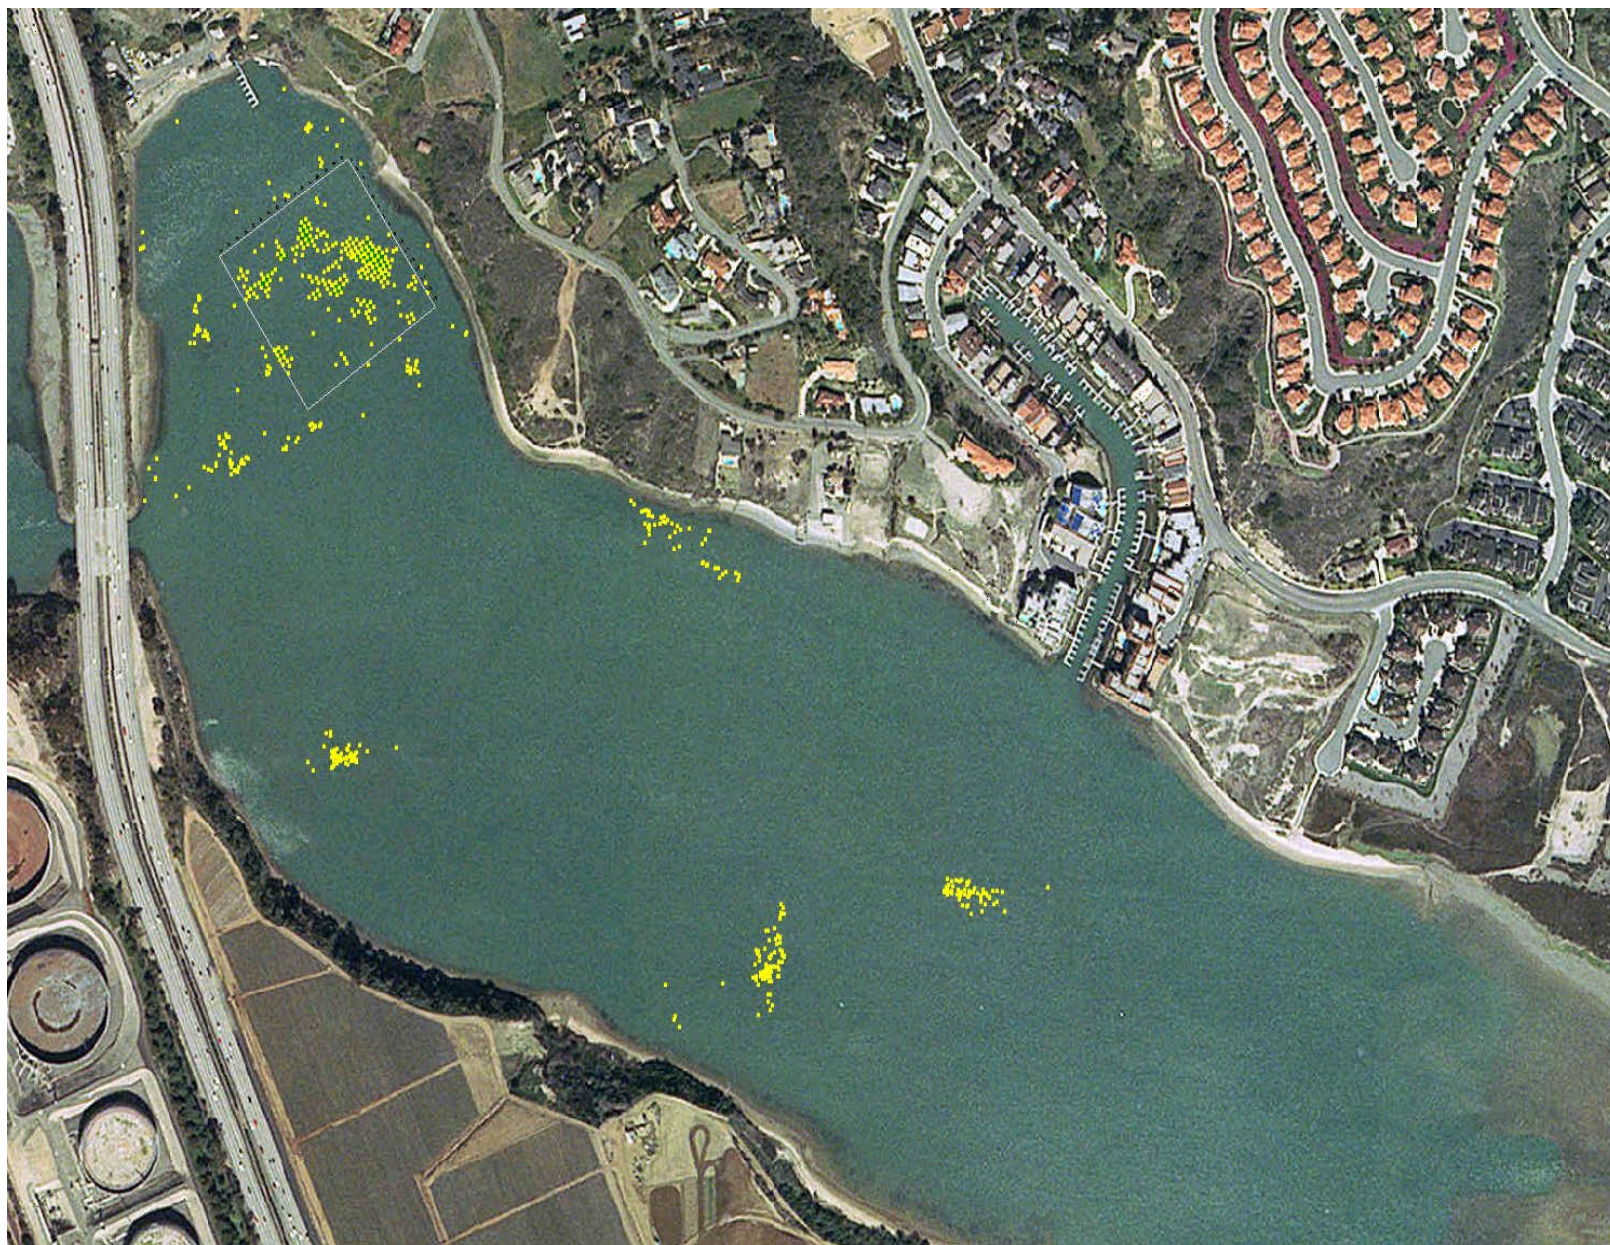
**Figure
3**

**Cumulative Distribution of *Caulerpa taxifolia* in Agua Hedionda
November 2001
Carlsbad, CA**

As of October 2001, Agua Hedionda Lagoon has been completely surveyed with high-intensity surveillance or better. Currently, a fall survey is being performed with eradication area surveillance level throughout the western half of the east basin and within all infestation areas. A cumulative total of 15,611 ft² of *Caulerpa* has been discovered since summer 2000 within the east basin (Figure 3). Eradication has kept pace with surveillance such that once a patch of *Caulerpa* is discovered, it is immediately treated. Thus, all *Caulerpa* discovered to date has been treated.
